## *“Riveting Reading”*

Civil Air Patrol  
North Carolina Wing  
Aircraft Maintenance

June 1, '20. Vol #31  
By Major Martin ‘Stryker’ Heller

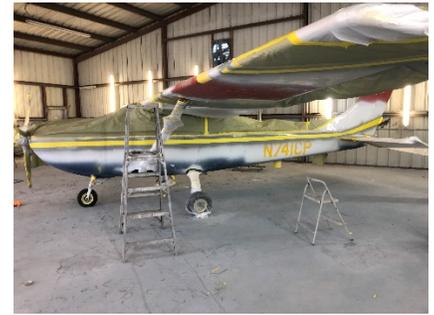
N741CP: 2006 Cessna 182 with just over 2,900 hours, had its clear coat peeling off; NHQ authorized its repainting.
