“Riveting Reading”

**Civil Air Patrol
North Carolina Wing
Aircraft Maintenance**

Oct 1, '20. Vol #35
By Major Martin ‘Stryker’ Heller

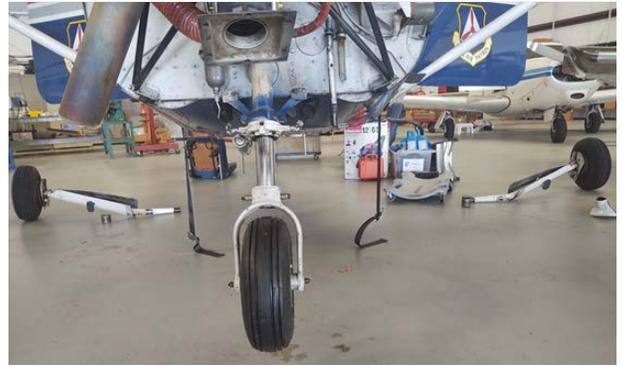
Above left: We couldn’t top the FY18 trophy presented to Capt Herring, so we bottomed the award with two more tiers for FY17 & FY19. Above right – N4813C needed new main gear bushings which required removing the main landing gear.

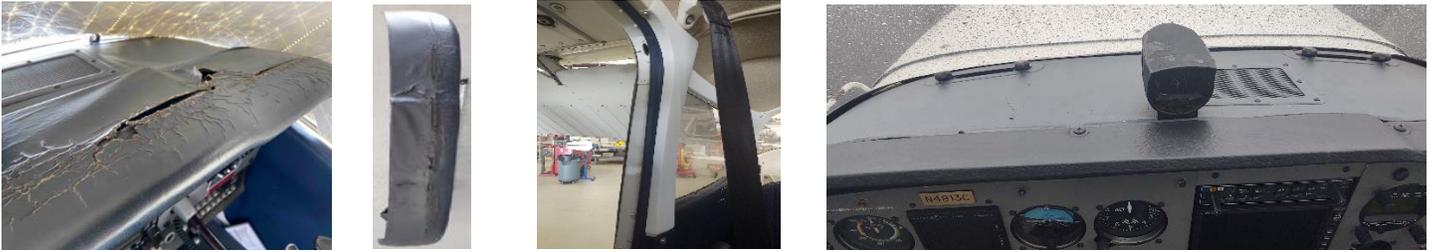
(Upper left) **N4813C's** Instrument Panel Eyebrow. It was recovered once already. (Center left) The old eyebrow with that covering removed (Center right) new door-trim; the old piece broke away. (Right) A new eyebrow, normally ~ \$1,300, was found on eBay for much less. The results; **N4813C** certainly, doesn't look like a 34-year-old aircraft parked outdoors.
