“Riveting Reading”

Civil Air Patrol
North Carolina Wing
Aircraft Maintenance

Jan 1, '21. Vol #38

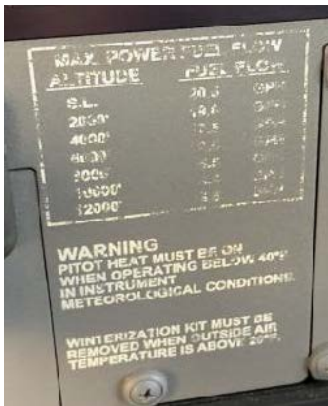
Do you see what I see? A list; fading on the panel...it won't bring us info at all... it won't bring us info at all. We believe this is an alcohol induced event... as in someone wiped isopropyl alcohol on the paint in the cockpit. And it's a newer plane too. Attachment 3 has a re-print of NHQ/LG's COVID19 care instructions. It mentions using diluted isopropyl alcohol, but nothing about the decals nor paint on the panel. Remember that chemicals can affect surfaces (maybe we shouldn't have slept through that chemistry class). The point is, watch what you are doing when rubbing/ spraying chemicals/ cleaners on surfaces. Why would somebody even be touching this area anyway? Every pilot I've seen just sets the power settings at the top of the green. BTW, the G1000 displays aren't touch screen neither...although you couldn't tell by all the finger prints.

3d. Wipe Away, Wipe Away, Wipe Away All.... (not): Don't just go cleaning things in the name of COVID19 protocols.

- Aircraft furnishings: We recommend using isopropyl alcohol (IPA)/water mix (60% IPA/40% water, by volume). For best results, wipe the surface with an IPA/water mix and let it dry. This mix can also be sprayed onto soft surfaces, like carpet, but **do not use this IPA/water mix on aircraft leather and windows.**

- Leather and windows: Any commercially available soap and water, such as dishwashing soap, can be used.
- Electronic displays: For glass products with anti-reflective (AR) coating, use a concentration of greater than 50% Isopropyl Alcohol (IPA) with a micro-fiber cloth to prevent scratches. Do not use bleach or Lysol® wipes, or any cleaners with Citric Acid or Sodium Bicarbonate as these can etch the coating on these displays. AR glass is used on displays and touchscreens in the Garmin G1000, G3000, and G5000 systems, as well as Collins Proline21 and Proline Fusion. Do not use IPA on acrylic, Lexan, or Polycarbonate screens such as the Garmin GNS 430/530.
