“Riveting Reading”

North Carolina Wing Aircraft Maintenance

May 1, '19. Vol #18
By Major Martin ‘Stryker’ Heller

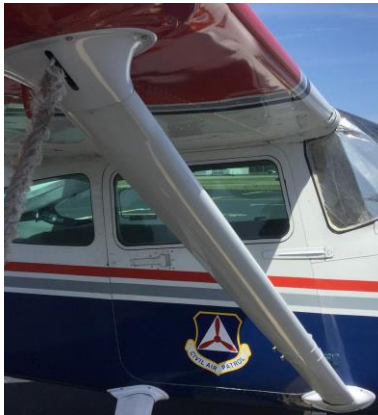
*N9930E’s New Fairings on struts,
wingtips, stabilizer and elevator*

N9930E’s elevator had some wear and tear issues, stemming from a previous repair. Considering we fly in an enlarged aluminum Pepsi can, there are certain parts you really want right...especially control surfaces. Even more so when you realize that this is a glider tow plane (Read: extra tail forces). The shop sent out for a replacement elevator which only took two weeks. Feeling vulnerable? The WWII, B-17 Flying Fortress’s control

surfaces are made of fabric. (Done to allow for quick repair without affecting its balance.) N9930E also received its long-awaited fairings, which is how they discovered the elevator issue in the first place. They re-welded the pilot seat support, trouble shot/ fixed the sagging brake pedal plaquing the aircraft, and a dozen things more. 'Thor' tried to receive a replacement KX-155 Bendix-King Comm/Nav, since the LCD digits were not lighting up. Unfortunately, after two bad radios were shipped, we sent her home to KLHZ awaiting the third replacement.

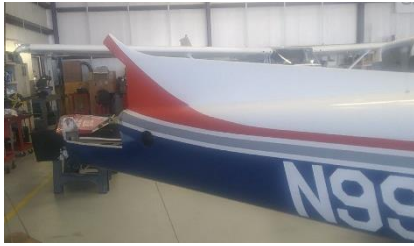
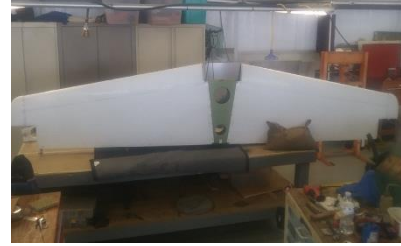
N99832 (the alternate glider tow plane) had a horizontal stabilizer crack in the center structure box. A small crack but a big repair. **N4813C** had it done 10 months ago. It's believed to be caused from pushing down on the horizontal stabilizer to move the aircraft. Then again, both aircraft were built in 1985. A **"Maintenance Mandate - Use of Tow Bars was issued on April 9th, 2019 stating the same.** (See photos below.) N99832 also had a pitot-static/transponder check done among many other minor repairs. (Go read your aircraft logbooks.)
